BRADFORD CITY No. 5 DAM
(TUNA CREEK DAM)

NDI No. PA 00026
PennDER No. 42-31

PHASE I INSPECTION REPORT
NATIONAL DAM INSPECTION PROGRAM

AUGUST 1979

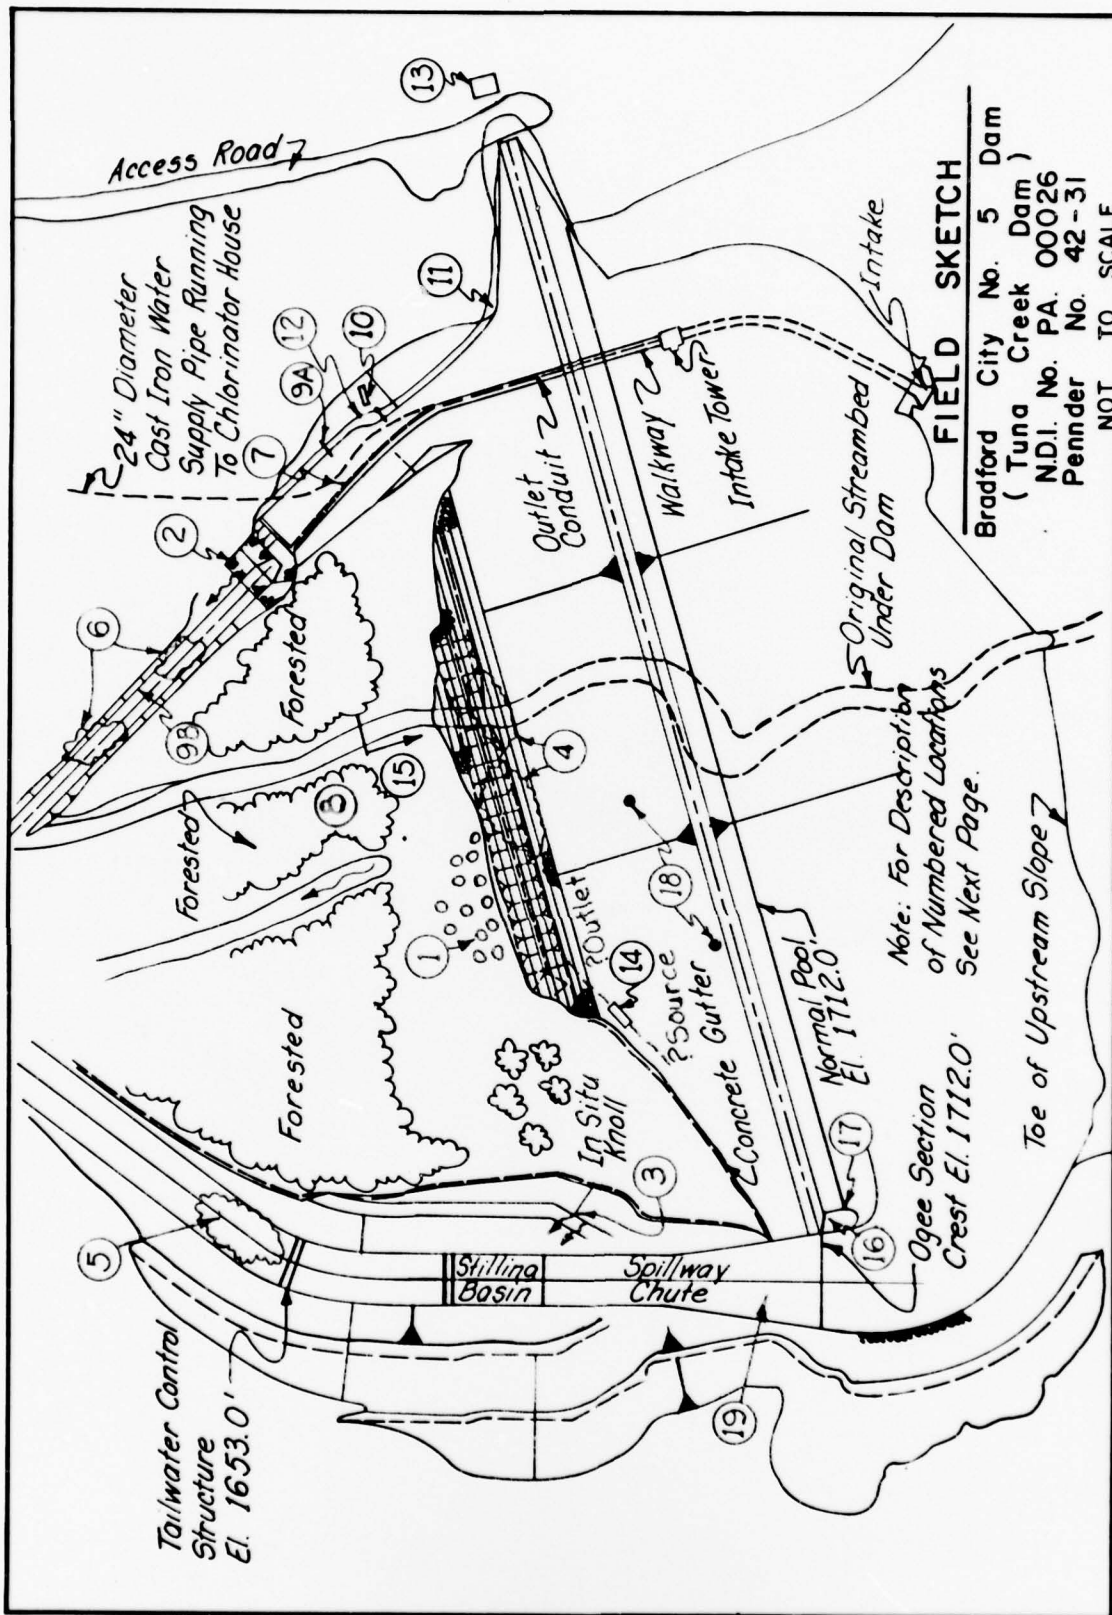
FIELD SKETCH

- b. Dam - Several holes were observed downstream of the rock toe drain to the left of the center of the dam (see field sketch). Most of these holes were approximately 2 foot by 2 foot in plan view and 18 inches deep. However, a few of these holes were deeper, and one measured 6 feet deep. These deeper holes had water standing in them up to 1 foot below the ground surface in the area. The exact cause of these holes could not be determined; however, there are several possible explanations for them: 1) they originally may have been animal dens, i.e., fox or rabbit, which were later abandoned because of water flooding them, 2) they may be sinkholes formed from surface runoff percolating through the waste fill and into the rock toe drain, or 3) they may be sinkholes formed due to the 4 inch clay pipe drain becoming disjointed, broken, or possibly not being outletted properly when constructed.

diameter pipe. The general direction of this pipe is pointed away from the basin at an approximately 60 degree angle to the centerline of the dam. The outlet of the pipe could not be located; however, it may coincide with the location of the observed flow (note number 8 on the field sketch) below the dam.

The observed seepage exiting from the in situ knoll (item 3 on the field sketch) should be periodically examined in the future to verify that the quantity of seepage is not increasing and transportation of fine material is not occurring. Should the extent of the seepage significantly increase with time, the condition should be studied in detail and appropriate remedial measures taken.

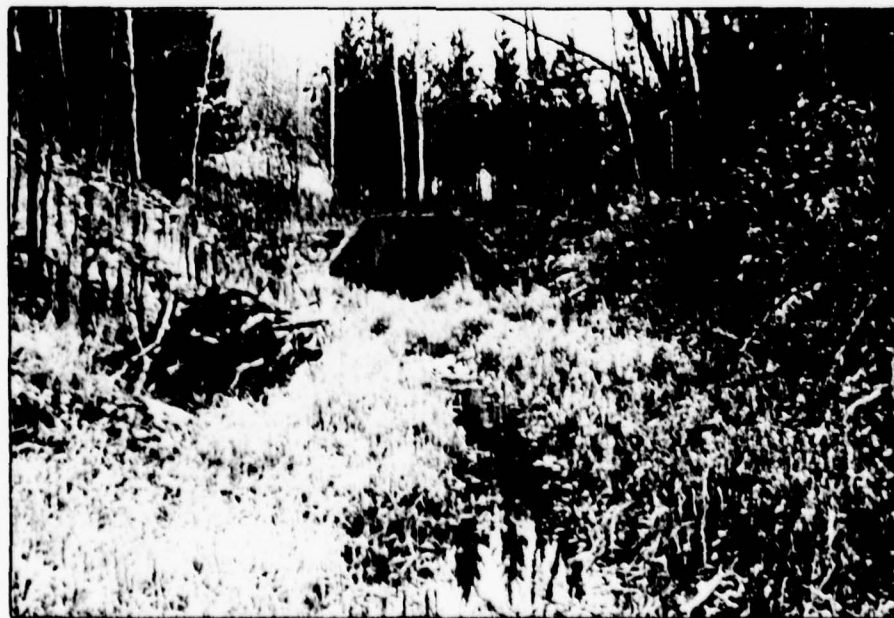
At the time of inspection, no flow was being discharged through the outlet conduit; therefore, the inspection team was able to walk up into the conduit and inspect its condition. Overall, the conduit was in very good condition; however, at several locations the concrete on the soffit of the conduit was spalled and the reinforcing bars exposed. Also, some debris was present in the discharge channel of the outlet conduit.

PHOTO 6. View of Outlet Conduit Head Wall and Discharge Channel
(Note: The Conduit is 8 Feet in Diameter at the Outlet Head Wall.)

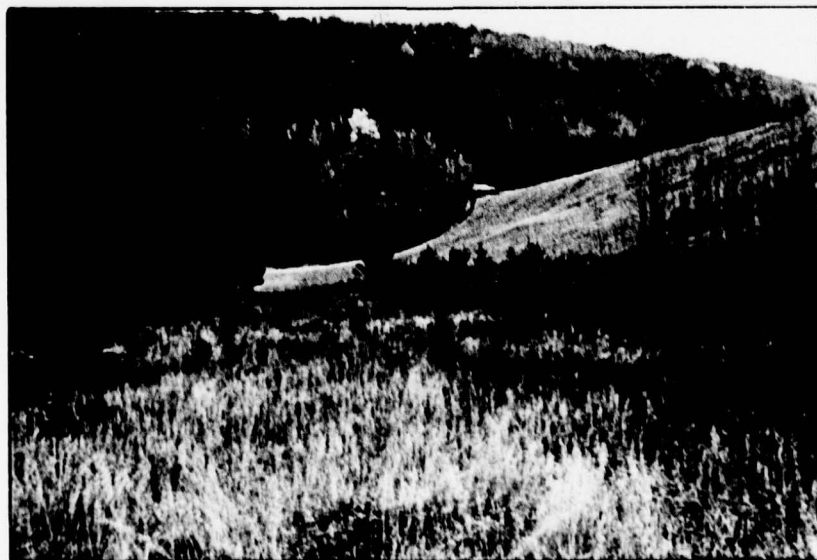
PHOTO 8. View of Rock Drain at Toe of Downstream Slope

location of the drain outlet noted in the correspondence could not be found.

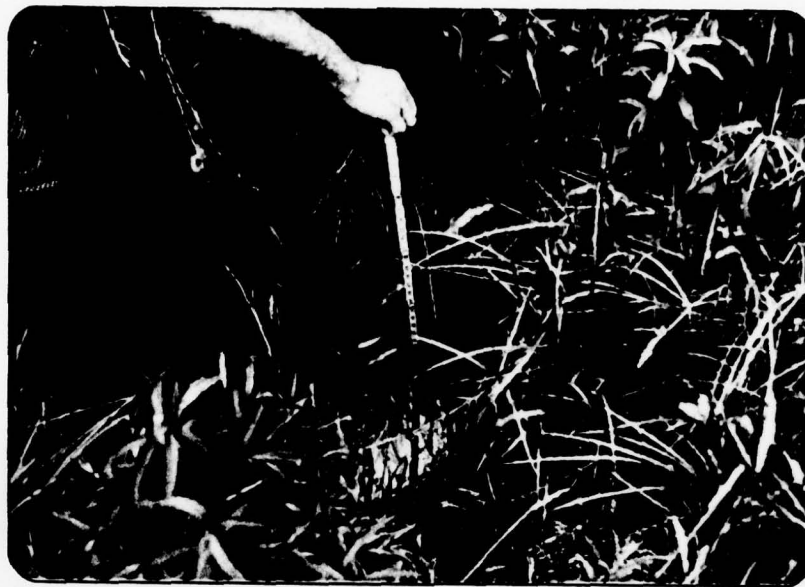
- a. Visual Observations - The cause of the vertical holes downstream of the rock toe drain should be determined by a detailed investigation in this area. The investigation should develop recommendations for the remedial work which will be necessary to correct the cause of these holes and repair the area. These holes and the probable cause or causes (see paragraph 3.1.b.) are not considered adverse to the structural stability and safety of the dam at the present time. However, the investigation should include the inspection of the 4 inch clay tile drainpipe located in the area and the cause of the observed seepage exiting the ground surface (item 8 on the field sketch) 200 feet downstream from the area.

PHOTO 9. Close-up View of One of Vertical Holes Downstream of Rock Drain

- 1) The owner should have a qualified professional engineer investigate, in detail, the cause of the vertical holes downstream from the toe drain of the embankment. Also, the condition of the 4 inch tile drain and the cause of the seepage exiting near this area should be evaluated as a part of the investigation.

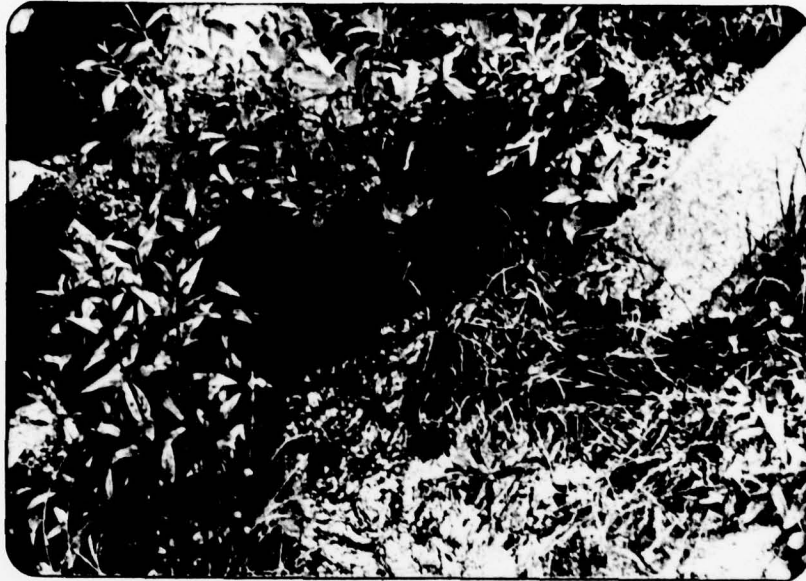
Groundwater or seepage was observed exiting the rock riprap behind the right wing wall of the outlet conduit outlet structure. This clear seepage was observed to be flowing at an estimated rate of 2 to 3 g.p.m. on 8 November 1978 and approximately 5 g.p.m. on 16 June 1979. The source of the water could not be determined during the inspection.

However, a possible source of this seepage could be a tile drain installed in the right abutment area near the grout cap to relieve seepage from a groundwater spring. The resident engineer during construction noted that the tile drain was extended below the toe of the dam. However, there is no plan drawing showing the exact location of the drain nor was a drain outlet located on the right side of the dam during the visual inspection. Therefore, it is the opinion of the inspector that the seepage was either natural groundwater exiting at this location or else the flow from this tile drain installed during construction.

The seepage exiting from behind the right wing wall of the outlet conduit structure (item 2 on the field sketch) should be examined frequently in the future to verify that the quantity of seepage is not increasing and transportation of fine material is not occurring. A seepage weir should be installed to monitor the rate of flow. The turbidity of the flow should also be measured and recorded. It is recommended that the outlet pipe for the catch basin adjacent to the access road on the right abutment be repaired and the discharge outletted downstream from the head wall. Additionally, it is recommended that the concrete gutter, or possibly a pipe, (item 11 of the field sketch) on the right side of the dam be extended to discharge downstream from the outlet head wall. Should the extent of the seepage area or characteristics of the seepage increase with time, the condition should be studied in detail and appropriate remedial measures taken.

PHOTO 11. Close-up View of Seepage Exiting Near Outlet Conduit Head Wall

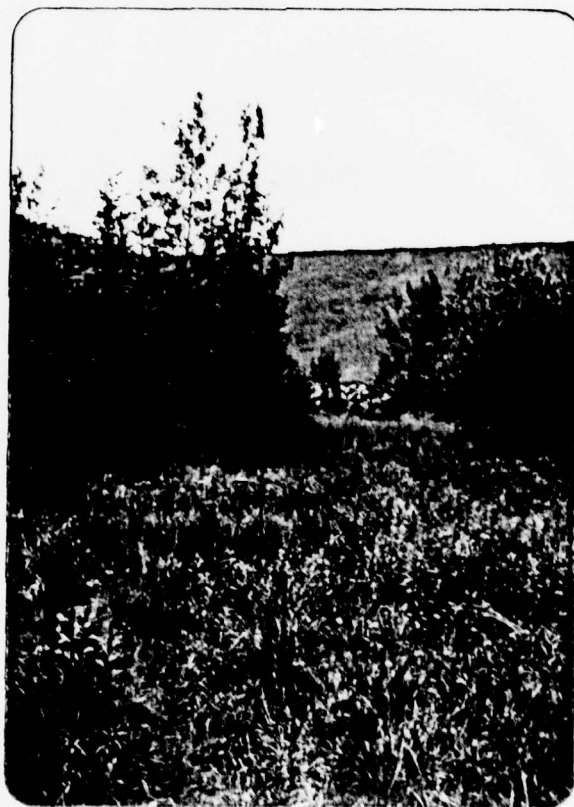
PHOTO 13. Location View of Photo 12 in Relation to Toe Drain and Dam Crest
